# Manhole Inspection Summary

Manhole # S25UU1016MH

Record Plat: **25UU1** Node: **016** Status: **New Manhole (Not in GIS)** Insp Date: **5/22/07 12:00 AM**

**Location** Address: **8 ST JOHNS RD**

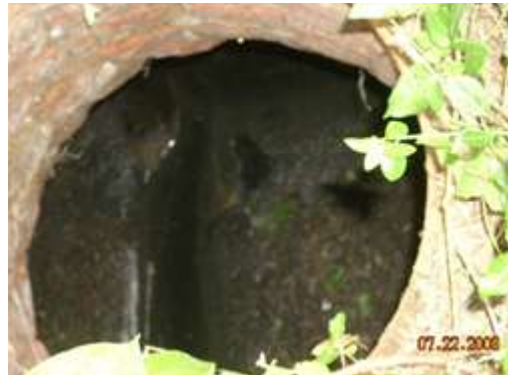
Comments **Several attempts were made to get a Good Top View photo. Due to an overhang these were the best pics. we could get.**

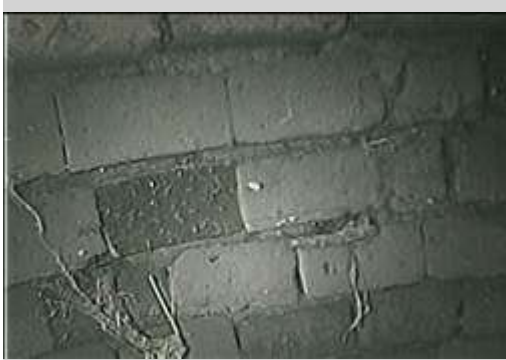
Defect

Bench and Channel debris.

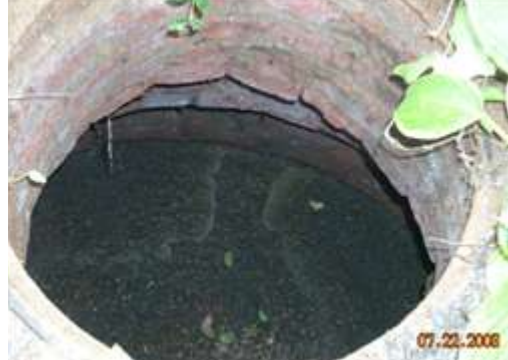
Defect

Corroded and missing step.

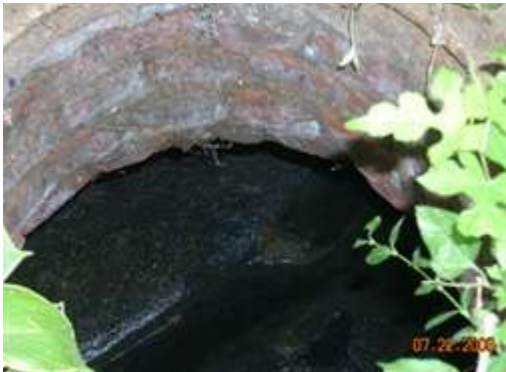
Defect

Adjustment and Corbel root intrusion and infiltration. Barrel infiltration.

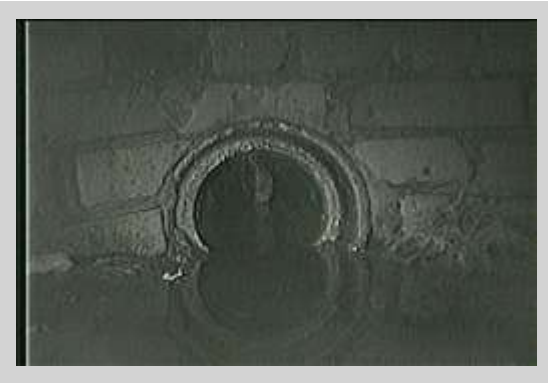
### 8 in. Circular Gravity Sewer Pipe Out @ 12 O'Clock

Barrel root intrusion and infiltration.

Infiltration: **Evidence** Pipe Seal Cond: **Roots**

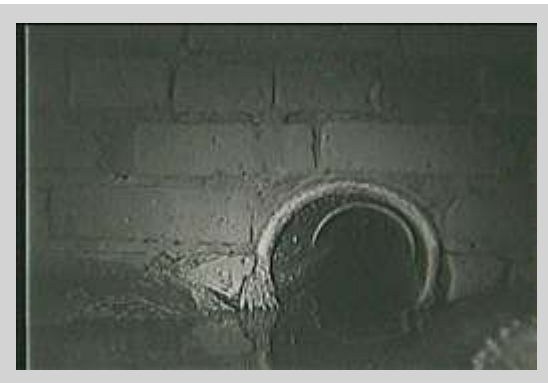
### 6 in. Circular Gravity Sewer Pipe In @ 3 O'Clock

Infiltration: **None** Pipe Seal Cond: **Roots**

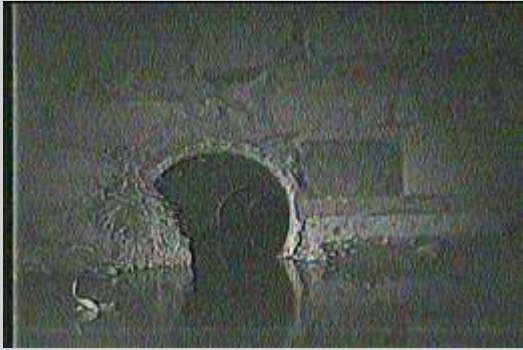
Pipe In @ 9 O'Clock

Barrel deterioration and infiltration.

Infiltration: **None** Pipe Seal Cond: **Roots**
